Flood hazard map of La Trinidad (NW Nicaragua). Method and results

G. Furdada · L. E. Calderón · M. A. Marqués

Abstract During the Mitch Hurricane event (October 1998), severe floods occurred in the village of La Trinidad (Departamento de Estelón, NW Nicaragua), which spreads at the margin of La Trinidad river. As a consequence, the need for hazard assessment and land use planning to reduce the effects of these natural processes arose. Nicaragua is a developing country, which means that there is a scarcity of good quality data on which to base these hazard assessments (i.e., lack of detailed topographic maps, lack of meteorological and discharge data series). Therefore, the main objective of the present work was to generate a flood hazard map of La Trinidad by means of a simple method, with a resulting map easy to understand and to use by the municipality for land use planning. There is no topographic map of the area at a more detailed scale than 1:50,000. So the main document that supports all the data and on which the final hazard map was based is the orthophotograph at 1:5,000 scale (generated from vertical aerial photographs taken in 2000). The method used was based on classi

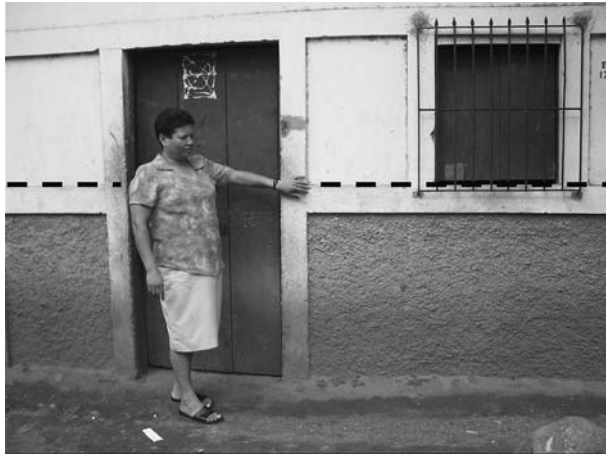
Fig. 2 Woman showing the level reached by the water during the Mitch hurricane event (black discontinuous line). La Trinidad, 2004

In La Trinidad case, the Mitch hurricane event (1998) produced the most important floods remembered in the region. As an advantage, it is very recent, so the forms are still quite fresh and memories are still quite good, abundant, and precise. Therefore, the flood related to the Mitch event was easy to reconstruct through photo interpretation, field-work and inquiries, and thus it was taken as the reference event.

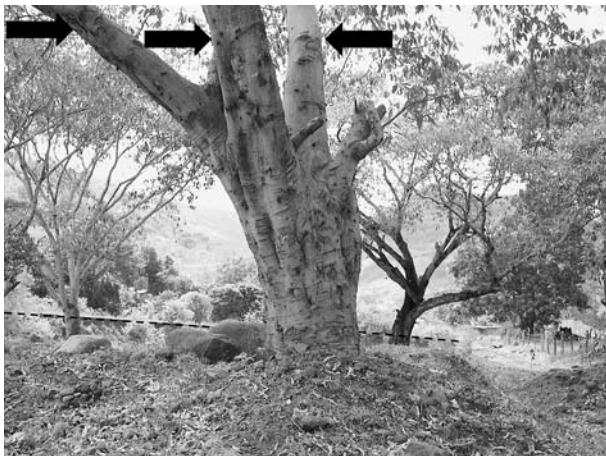
Fig. 3 Impact marks on the trunk of a tree that grows on the La Trinidad river bed. The impact marks were produced during the Mitch hurricane event (black arrows indicate the higher impacts, produced by floating trunks). In the background, the level of the lower terrace is indicated with a black discontinuous line. La Trinidad, 2004

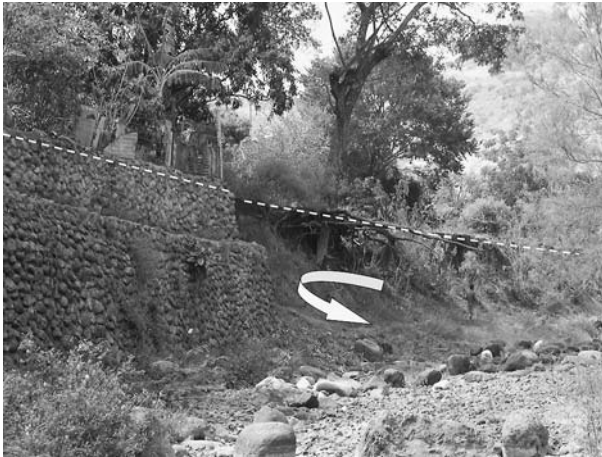
Fig. 4 Image of the concave margin of a meander. Undermining is evident below the roots of the tree, where unconsolidated sediment is being eroded (white arrow). The dike, built after the Mitch hurricane event, is obviously too short and undermining is beginning to act behind it and therefore it will be ripped off. The lower terrace level is indicated with a white discontinuous line. La Trinidad, 2004

Reaches affected by undermining (Fig. 4) were mapped. It shows, on one hand, some preferential overflow points, and on the other hand, unstable reaches and tendency of meander evolution. Consequently, undermining indicates possible changes in flood prone areas.

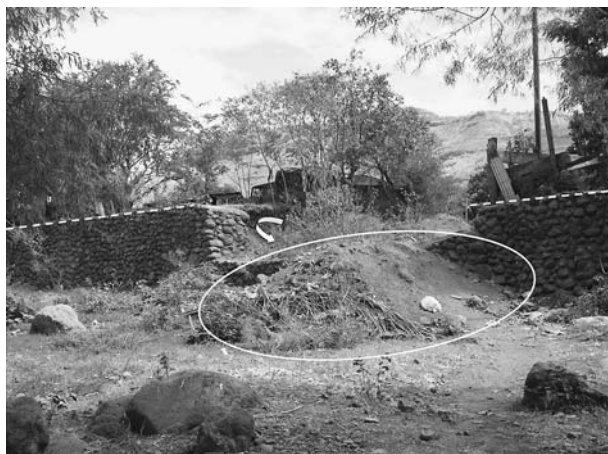
Fig. 5 Image of a filling on La Trinidad river bed indicated with a white circle. The dike, built after the Mitch hurricane event, presents a discontinuity and erosion is beginning to act behind it (white arrow). The lower terrace level is indicated with a white discontinuous line. La Trinidad, 2004

Damage produced during the Mitch event (which reflect the flow energy) and post Mitch anthropogenic obstacles were also mapped and considered. Figures 5 show an example of a too short dike in a meander undermining zone and of an anthropogenic deposit into the river bed.

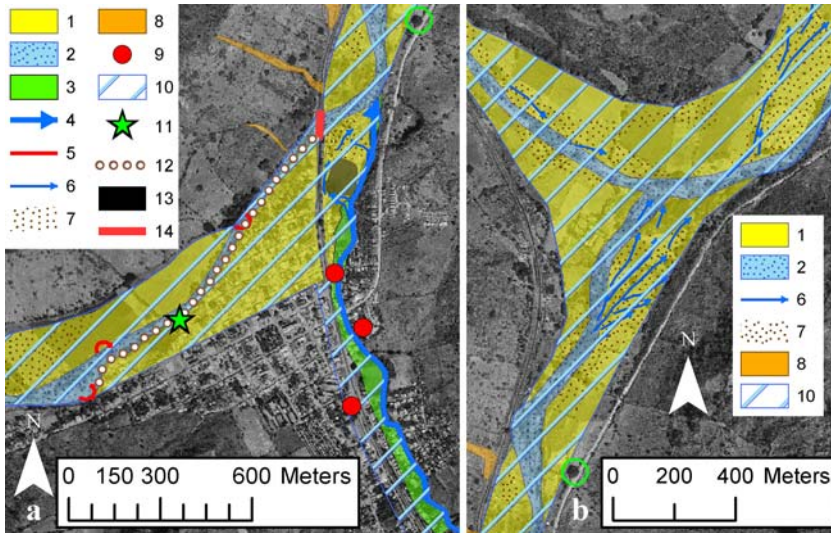
Fig. 6 Integrated Geomorphologic Maps. (a) Two sectors of La Trinidad study area. The green circle indicates the same tree in the two sectors: lower terrace (2D3 m above the main channel); river bed, including the main channel; lower terrace of La Chingastosa stream (1.5 m above the main channel); La Chingastosa main channel; undermining; 6 preferential overflow channels modeled during the Mitch event; 7 sediments deposited during the Mitch flood debris flows; 9 points with information from inquiries selected because their relevance for reconstruction of the reference flood (Mitch event); anthropic fillings; 12 dike; 13 stadium; 14 bridge

An example of this map, made on the orthophotograph, is shown in Fig. 6. The legend of the map shows the main geomorphologic features (symbols 1–8), some relevant points where eyewitness information was provided and the reconstruction of the reference event (symbols 9 and 10) and the anthropogenic defenses and obstacles to the flows (symbols 11–14).
