Engineering Geology 72 (2004) 57–72

A pragmatic approach to debris flow hazard mapping in areas affected by Hurricane Mitch: example from NW Nicaragua

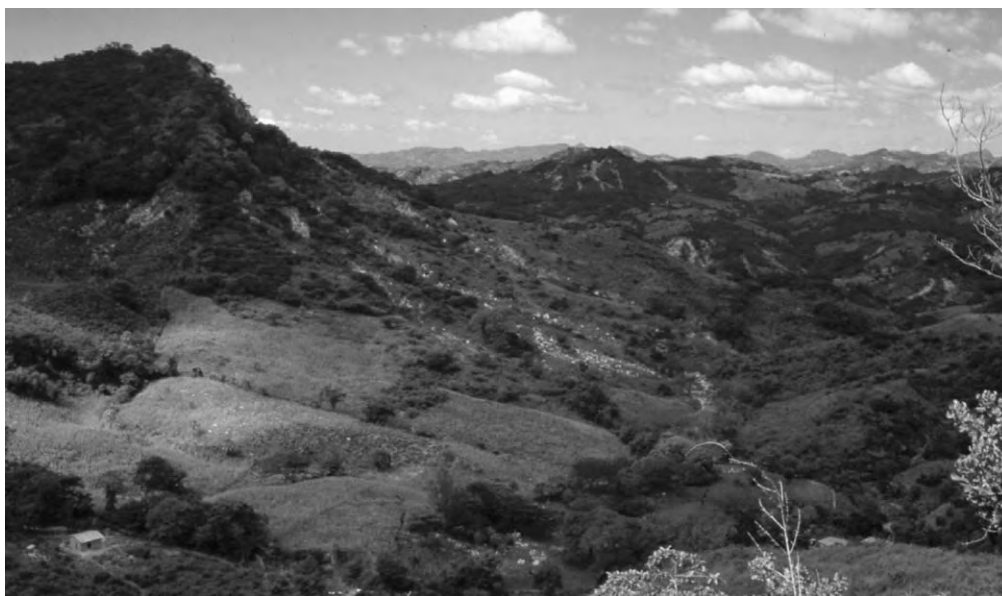
Fig. 2. General aspect of the study area. View looking west from Cerro Chávez (Fig. 4C). Cerro Morroñoso is on the left, and Cerro Nancital on the background. White patches correspond to large debris flows and areas affected by rockfalls, which were triggered by Hurricane Mitch.

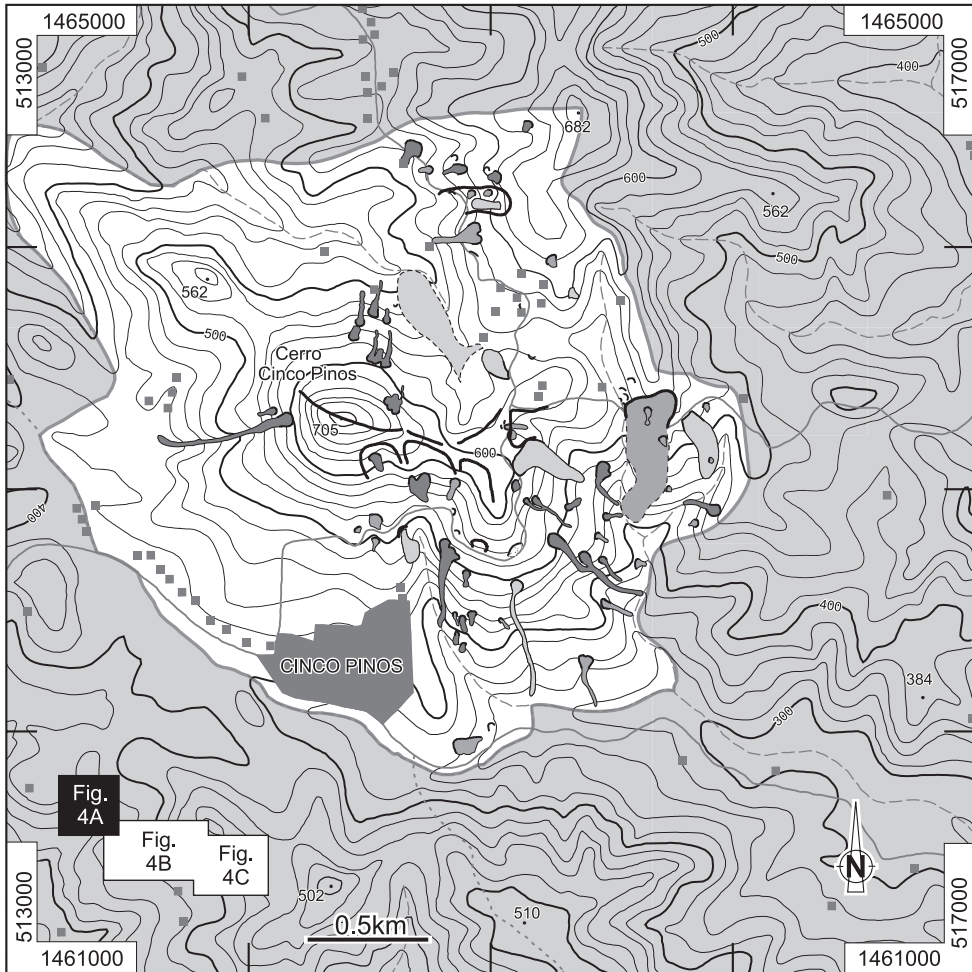
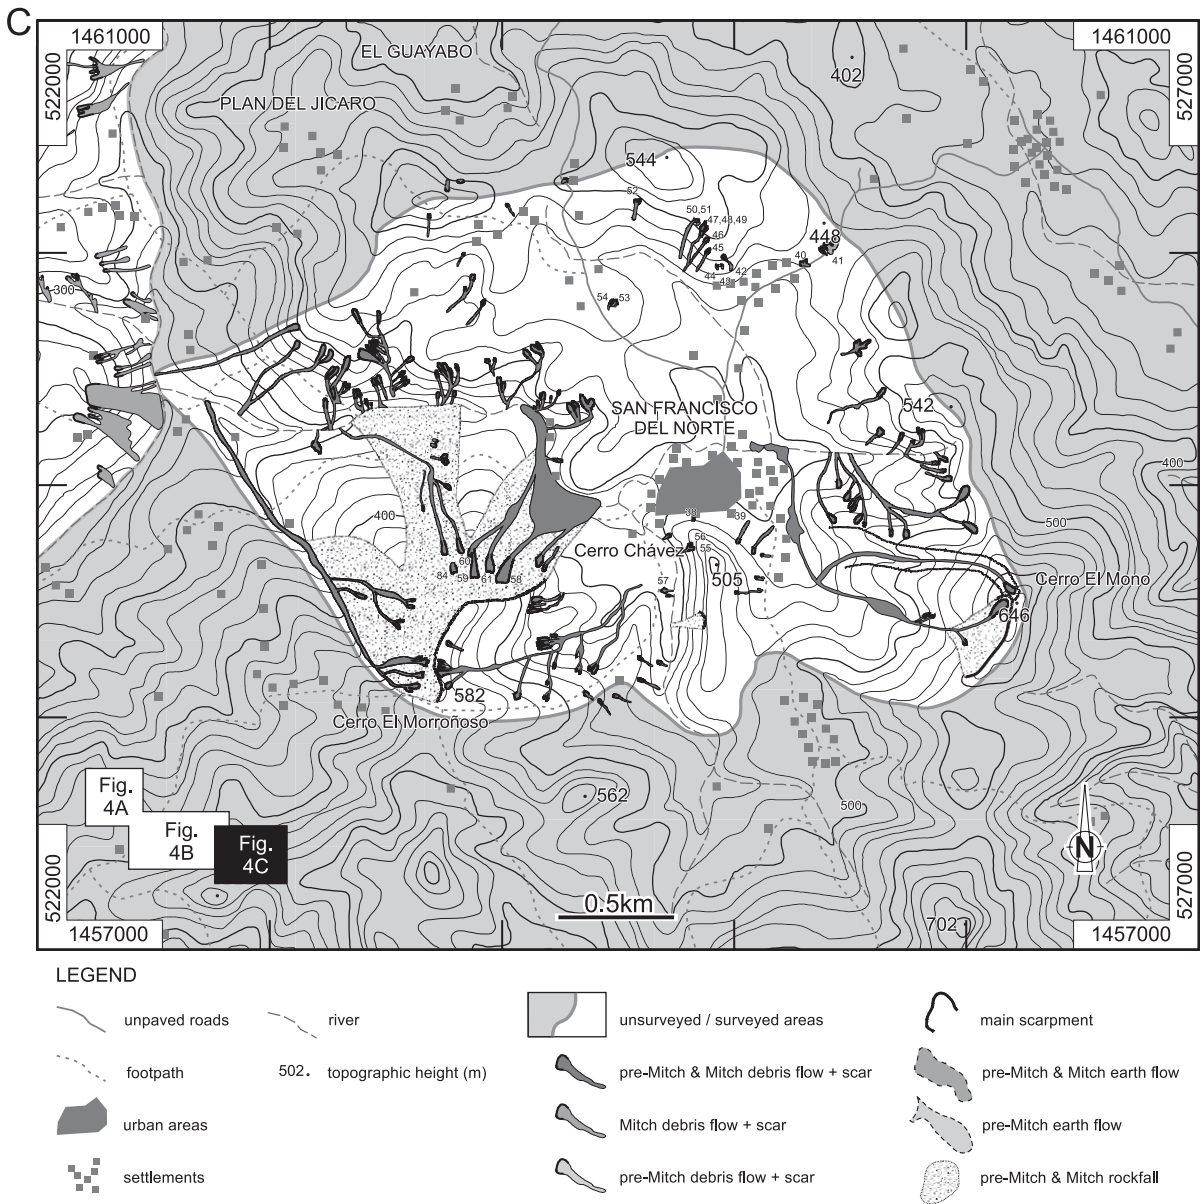
Fig. 4. (A) Landslide inventory map of the Cinco Pinos area. Elevations are in m, and coordinates are Transverse Mercator. (B) Landslide inventory map of the Cerro San Diego and El Nancital areas. Elevations are in m, and coordinates are Transverse Mercator. (C) Landslide inventory map of the San Francisco del Norte area. Elevations are in m, and coordinates are Transverse Mercator.

Landslide mapping was restricted to three areas (Fig. 4A–C), covering a total area of 19.9 km². These target localities were selected on the basis of (1) high landslide density, (2) varied bedrock, (3) presence of vulnerable elements such as settlements and roads, (4) wide range in landslide typology and size, and (5) relatively good accessibility.

The present study implicitly uses the Hurricane Mitch rainfall event as a reference. Both the landslide map and the susceptibility map (Figs. 4 and 6) are based on data taken from landslides triggered during Hurricane Mitch. For example, all the measurements on slope angles have been taken from debris flows triggered by this extreme rainfall event. Slopes with gradients exceeding 20° could be more than sufficiently stable under most rainfall events and could be triggered only during extreme events such as Hurricane Mitch. Thus, the resulting hazard map (Fig. 8) should be seen as covering worst-scenario cases, involving rainfall intensities similar to the reference event. Obviously, if the recurrence interval of the reference event was very large, the resulting hazard map would be excessively pessimistic, would impose unnecessary constraints on management decisions, and would have the drawback of becoming costly. Nevertheless, the return period of around 100 years estimated for Hurricane Mitch rainfall at meteorological stations in the proximity can be considered suitable for the present assessment. In addition, the worst-scenario approach adopted has the advantage of providing a reassuring safety factor.

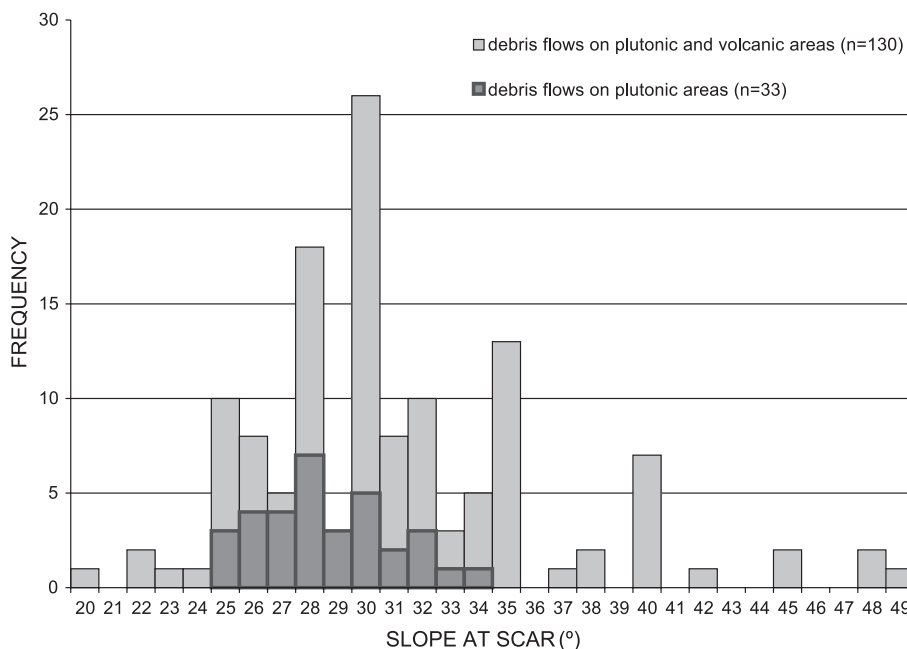
Fig. 5. Frequency distribution of debris flow failure angles measured in the field. The histogram in dark-grey corresponds to angles measured both in volcanic and plutonic areas. The superimposed histogram in white corresponds to angles measured in plutonic bedrock areas.

When considering both volcanic and plutonic bedrock areas, the sample of 130 measured debris flow failure angles ranged from 20° to 49°. To detect any difference in behaviour between volcanic and plutonic bedrock areas, both subsamples were plotted separately (Fig. 5). To determine the areas with slope angles susceptible to failure, we must focus on the lowest angles of the total range rather than on the central values of the population. The plutonic subsample is close to a normal distribution,

with the exception of a sharp drop in frequency at angles lower than 25°, with no angles measured in the 20–24° range. This may be due to undersampling, or to the fact that slopes below 25° may be underrepresented in plutonic areas. This suggests that the lower values of the population may be around 20° not only for volcanic bedrock but also for plutonic bedrock areas. Thus, 20° may be taken as the threshold stability angle of debris flows triggered by the rainfall conditions experienced during the Hurricane Mitch event.

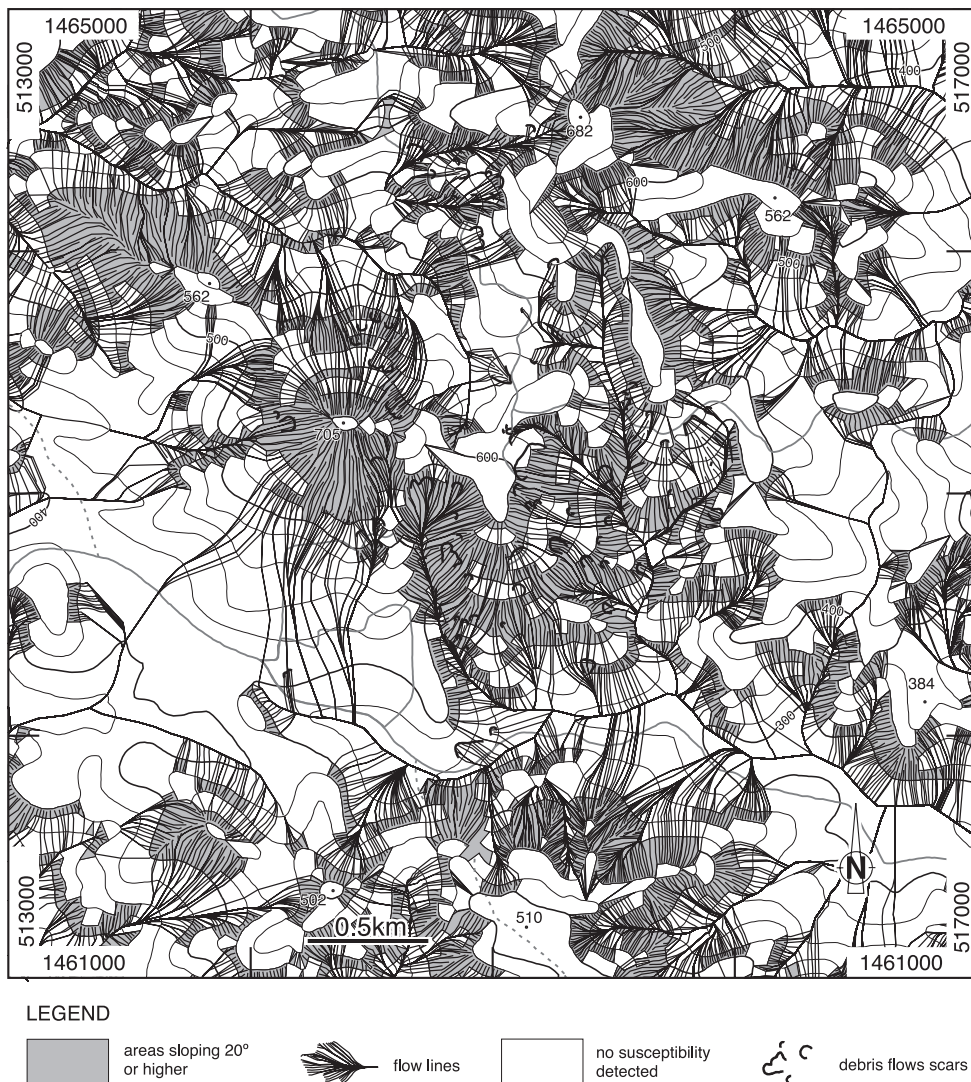
Fig. 6. Example of the susceptibility map corresponding to the Cinco Pinos area (locality in Fig. 4A). Areas highlighted in grey correspond to the ones sloping equal to or higher than 20° , and are the ones considered susceptible to failure. Flow lines correspond to possible debris flow paths, taking the areas highlighted in grey and mapped scars as possible source areas. See text for detailed discussion.

lines merged together along the drainage network and their downslope length was only limited by the extent of the DTM (Fig. 6). The areas potentially affected by debris flows correspond to the union of areas sloping $\geq 20^\circ$ and the areas crossed by the flow lines.

$\geq 20^\circ$ range. Comparison of the mapped scars and the highlighted areas in the slope map (Fig. 6) reveals that 28% of the scars do not match the slope areas in the model. This indicates that the DTM does not describe all the relevant topographic variations in sufficient detail for an accurate slope map to be constructed. A second set of flow lines were generated using the mapped scars as possible source areas in order to
