Landslide Response to Hurricane Mitch Rainfall in Seven Study Areas in Nicaragua

Open-File Report 01-412-A

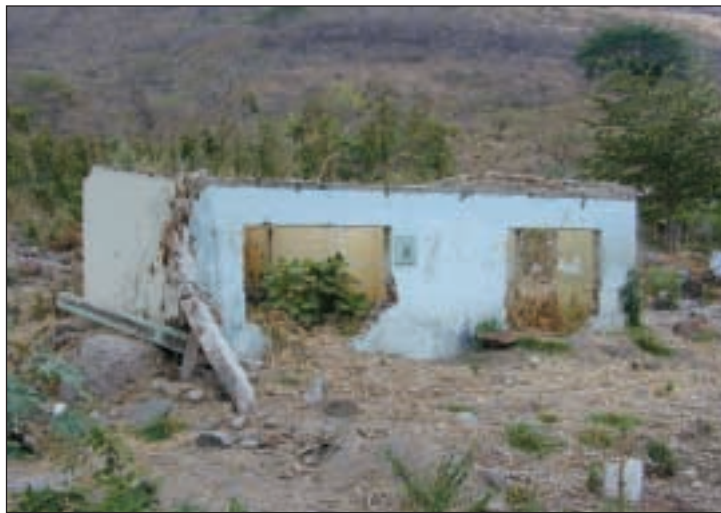
Figure 5. Structures destroyed by debris flows behind hospital at La Trinidad.

We mapped 655 landslides in this study area from aerial photographs (plate 3). Most of the debris flows initiated as landslides up to a few tens of square meters in area, a few meters in depth, and traveled less than 1 km downslope, commonly stopping on the gently sloping colluvial apron downslope from the resistant flow unit. However, the landslide density was particularly high and the sizes of the landslides were particularly large, relative to the rest of the study area, on the steep hillslopes that bound the mesas above the towns of San Francisco and La Trinidad in the northwest part of the study area (plate 3). Material from landslides with areas up to about 20,000 m² traveled at least 3 km over the colluvial apron and onto the flood plains of Quebradas Seca and La Rancho. Between the towns of San Isidro and La Trinidad, a landslide that initiated in the Coyol Superior ignimbrite mobilized into a debris flow that traveled approximately 1 km down a steep channel, eroding significant volumes of material (fig. 4). Material from other debris flows crossed the highway between La Caña and La Trinidad in numerous locations. Immediately south of La Trinidad, several structures behind the hospital were damaged or destroyed by a series of coalescing debris flows generated from the steep hillslopes behind the town (fig. 5).

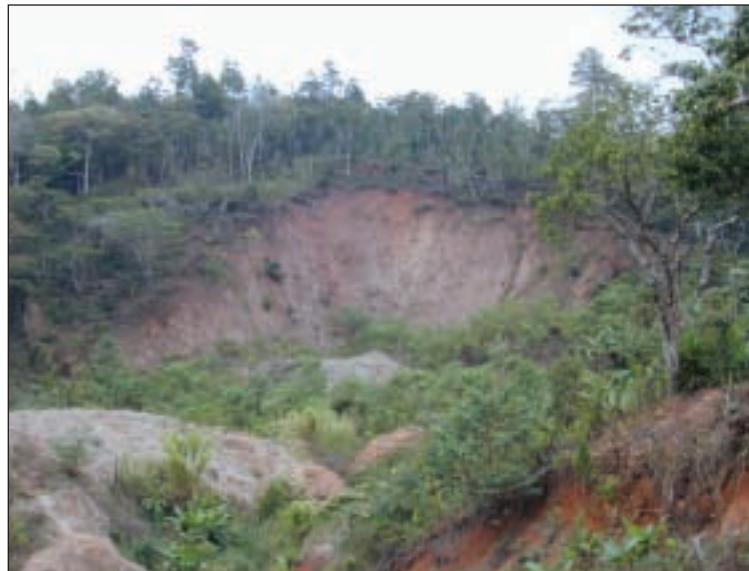
Figure 9. Headscarp (approximately 8 m high) of landslide in deeply weathered materials in northern Matagalpa study area.

Most of the debris flows initiated as landslides of up to a few tens of meters in area, 1 to 5 m in depth, and traveled tens of meters downslope. Debris flows that moved into well-developed channels traveled the farthest, up to 2 km in one case. During the field reconnaissance we observed that landslide scars most commonly occurred in areas of weathered and/or hydrothermally altered materials (figs. 8 and 9). In addition, depth of

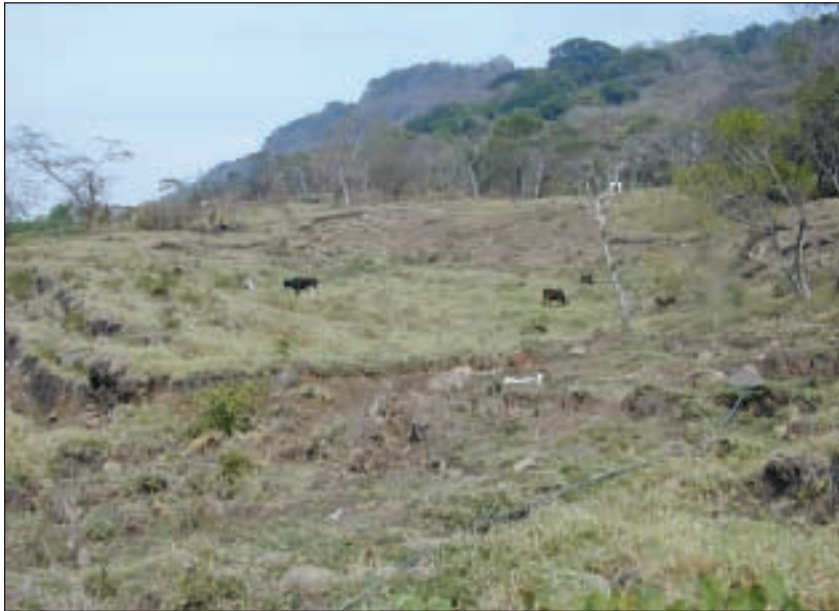
Figure 11. View up slope of earth flow at San Simón de Palcala. Note the hummocky topography, large scarps and cracks in the foreground, and headscarp behind the cows.

An earth flow that developed within a pasture at San Simón de Palcila (northwest part of study area) was visited during the field reconnaissance (figs. 10 and 11). Movement on the earth flow has destroyed one house and a church. The earth flow is about 40 m across, 200 m long, with the hummocky topography and the distinct lateral ridges diagnostic of earth flows. The farmers whose house was destroyed reported that the first movement on the earth flow occurred during Hurricane Mitch, but the most significant movement has occurred over a long time period since the hurricane. This earth flow occurred within an apron of deposits that line the ridge. The deposits show evidence of movement by landsliding in the past.
